FACE INVESTIGATION

SUBJECT: Machinist is Pinned Between Parts of Metal Materials Handling Equipment

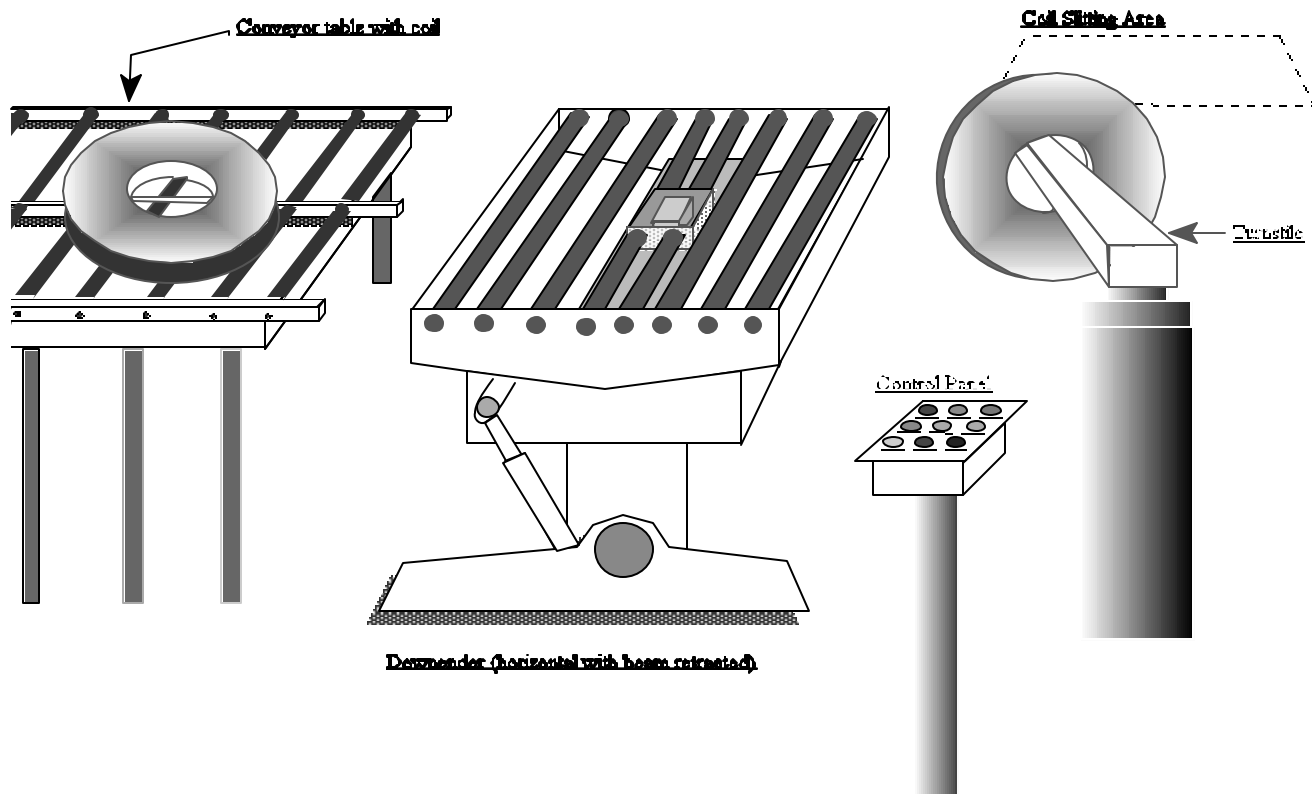
Figure 1 - 95WI05501

The production activities of the company were conducted in two main rooms of the building occupied by the company. Metal stock was rolled thin, annealed and wound into rolls (coils) in the first room. The second room had an annealing furnace, coil slitting machines, a turnstile, downender and a conveyor table to carry the slit coils to the shipping area. After the coils were prepared to the customer's specifications, they were transferred from the coil-slitter to a turnstile arm that then rotated 90° toward the downender. While this was occurring, the downender tipped down, and a metal beam pushed out from the center of the downender to receive the coils after the beam was aligned with the turnstile arm. (See Figure). The coils were transferred from the turnstile arm to the beam by an automatic pusher when the gap between the arm and the beam was closed. If the automatic pusher failed to completely transfer the coil to the beam, the company procedure involved having an employee manually push the coil. Then the vertical downender tipped back automatically to the horizontal position, the beam retracted, and the coil moved down the conveyor line. The supervisor controlled the machines by depressing buttons on the control panel, located in front of the conveyor. The machines operated automatically until each cycle was completed. There were no warning lines around the turnstile or machine areas, nor were guards in place at the pinch point between the beam and the turnstile arm.

Discussion: Moving machine parts present dangers including pinching, crushing, entanglement, or shearing. Employers should ensure that access to hazardous areas is sufficiently controlled by guards or devices to prevent employee contact with the hazardous machine parts. In this case, a crush point between the turnstile arm and the downender beam was fully exposed to employees working near the machine. OSHA standard 29CFR 1910.212(a)(1) requires machine guarding to protect employees from hazards created by moving equipment. An additional factor of the hazard was the automatic feature of the machine controls, which permitted continued machine activity after the control buttons were pushed, regardless of an employee's presence in the hazardous area. Interlocked guards or gates, pressure sensitive floor pads, or presence-sensing devices or other physical measures to prevent employee contact with moving machine parts, and might have prevented this fatality

Recommendation #1: Employers should ensure that access to hazardous areas is sufficiently guarded.

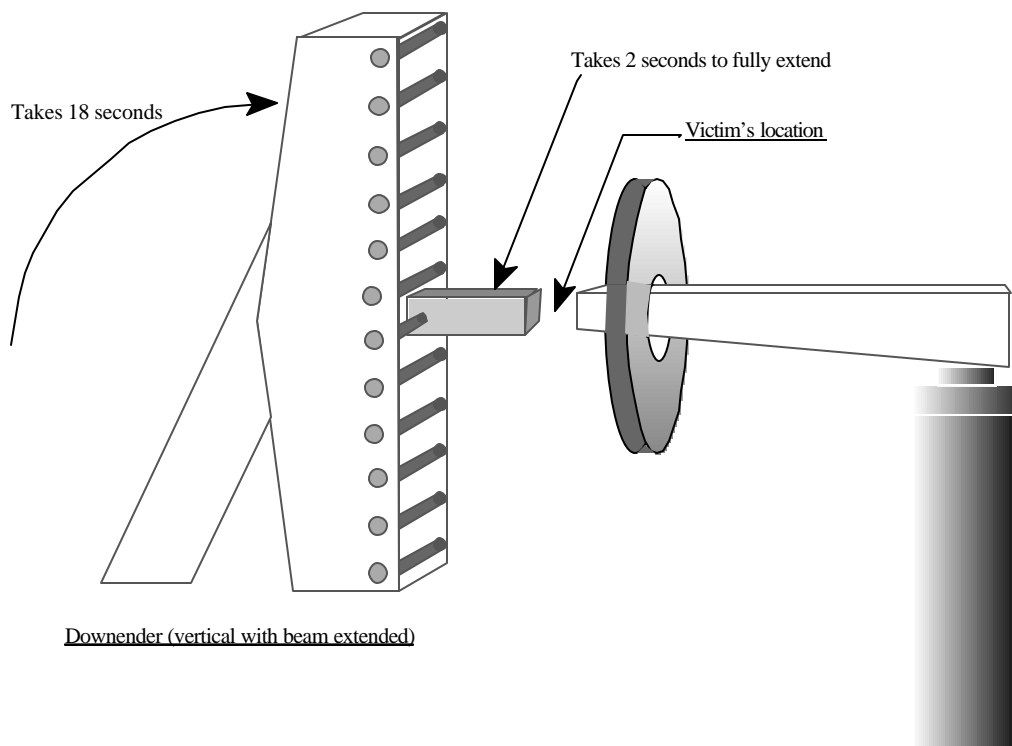
Figure 2 - 95WI05501

the supervisor pushed the button to lower the downender to the horizontal position. He left the control panel area to remove materials from the conveyor while the victim was standing near the turnstile arm. The event was unwitnessed, but apparently the victim pushed the control panel button that caused the downender to tilt to the vertical position, and the beam to project. The supervisor heard the victim call for help, and turned to see him pinned between the turnstile and the downender beam. He went to the control panel and tried to retract the beam by using the button controls, but was unsuccessful. He then pushed the emergency stop button, and cut the hydraulic line to retract the beam. The victim was transported to the hospital by EMS services, where he was pronounced dead.
